# **Navajo Abandoned Uranium Mine**

## **Site Screen Report**

### **Mesa IV, Mine No. 1 AUM Site**

#### **Navajo AUM Northern Region**

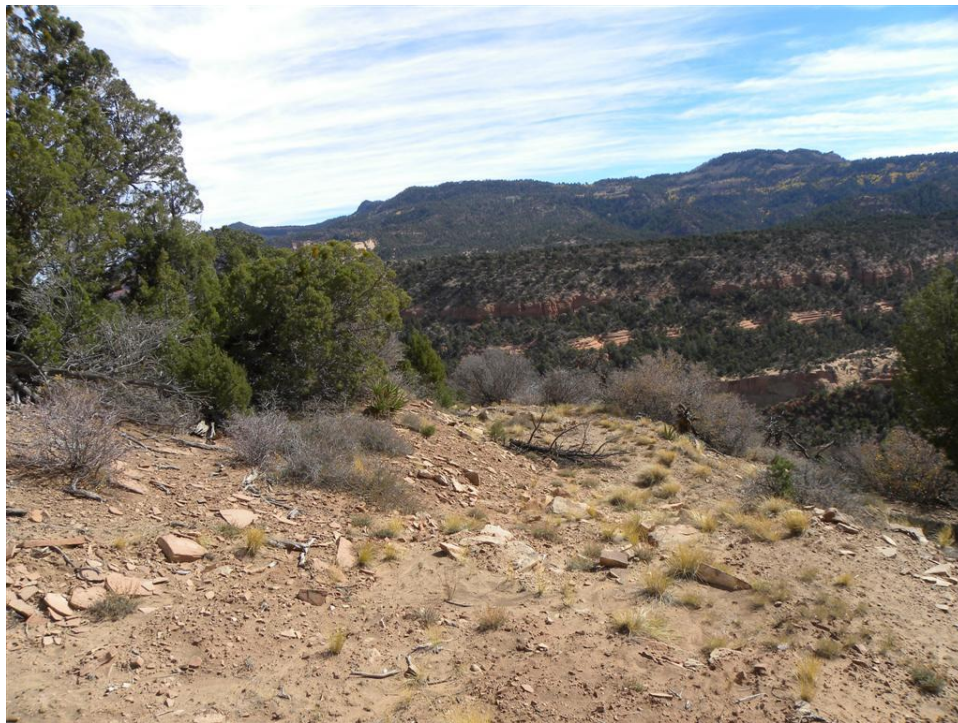
Photo 1. Mine site

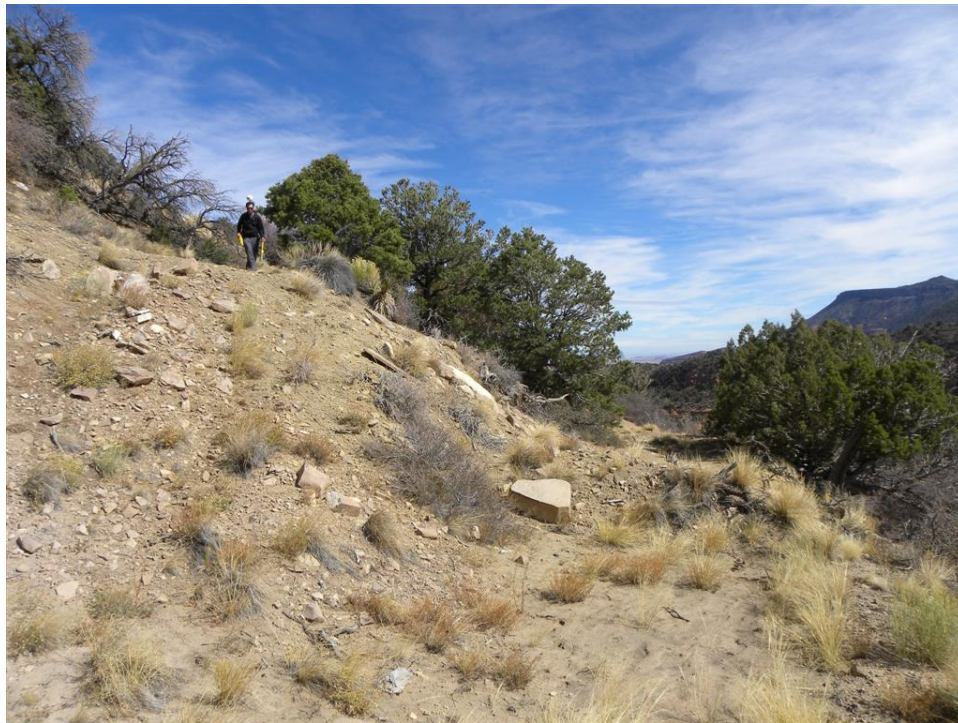
Waste pile in northwest, scattered waste debris throughout site, with a total estimated volume of 2,000 yd<sup>3</sup>

Photo 2. Some scattered waste rock

Scattered unreclaimed waste debris

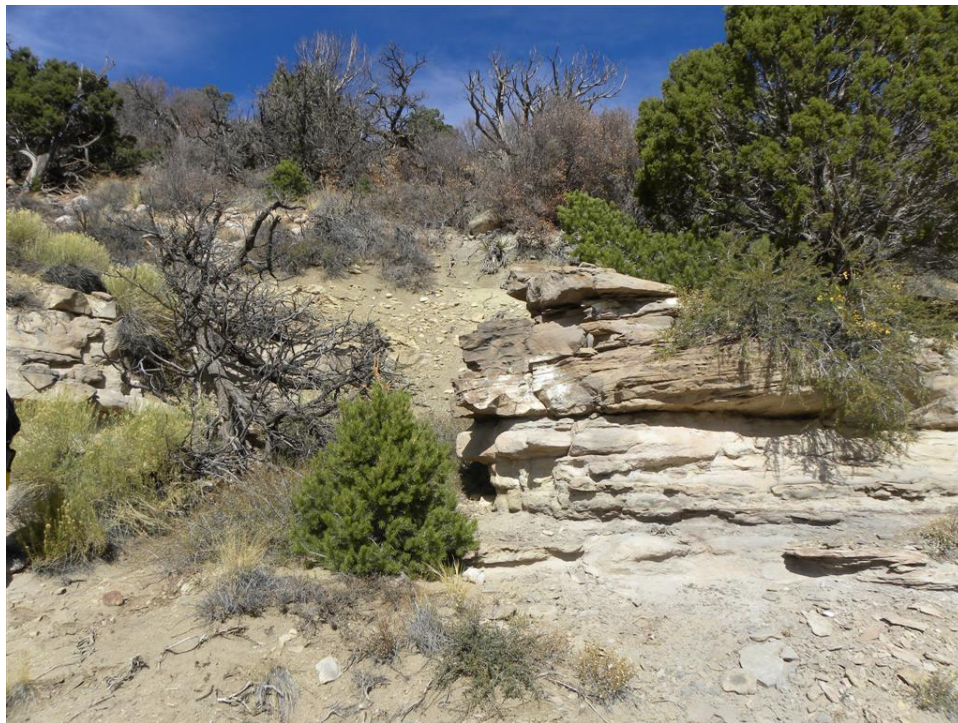
Photo 3. Waste rock

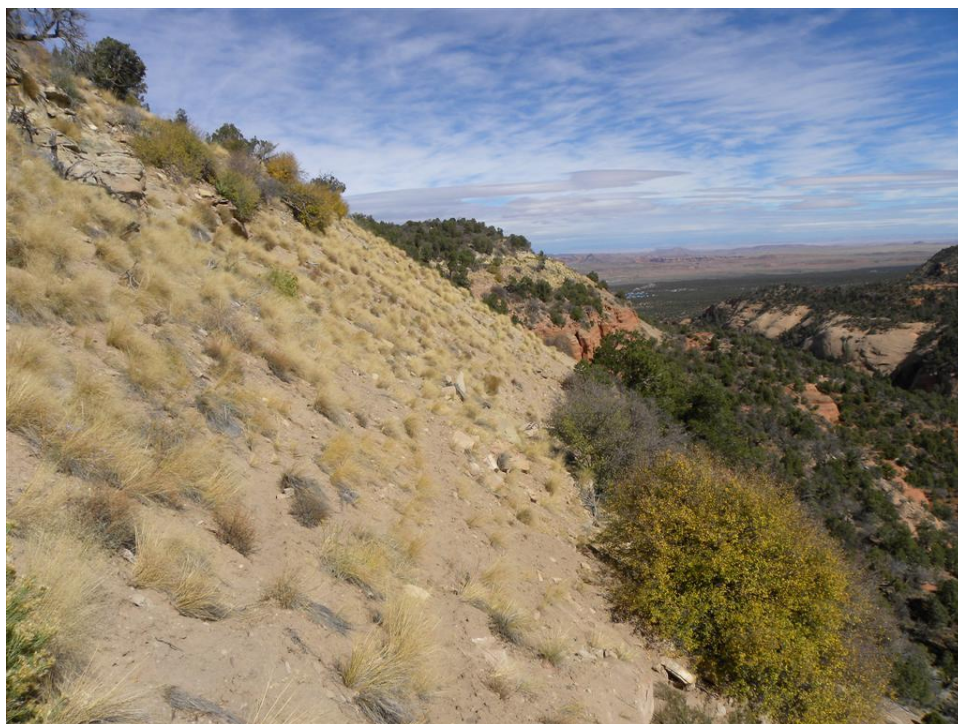
Photo 4. Steep incline
